MorganAM&T™

Company Profile

Brush Surface Conditions

Commutator Surface Conditions

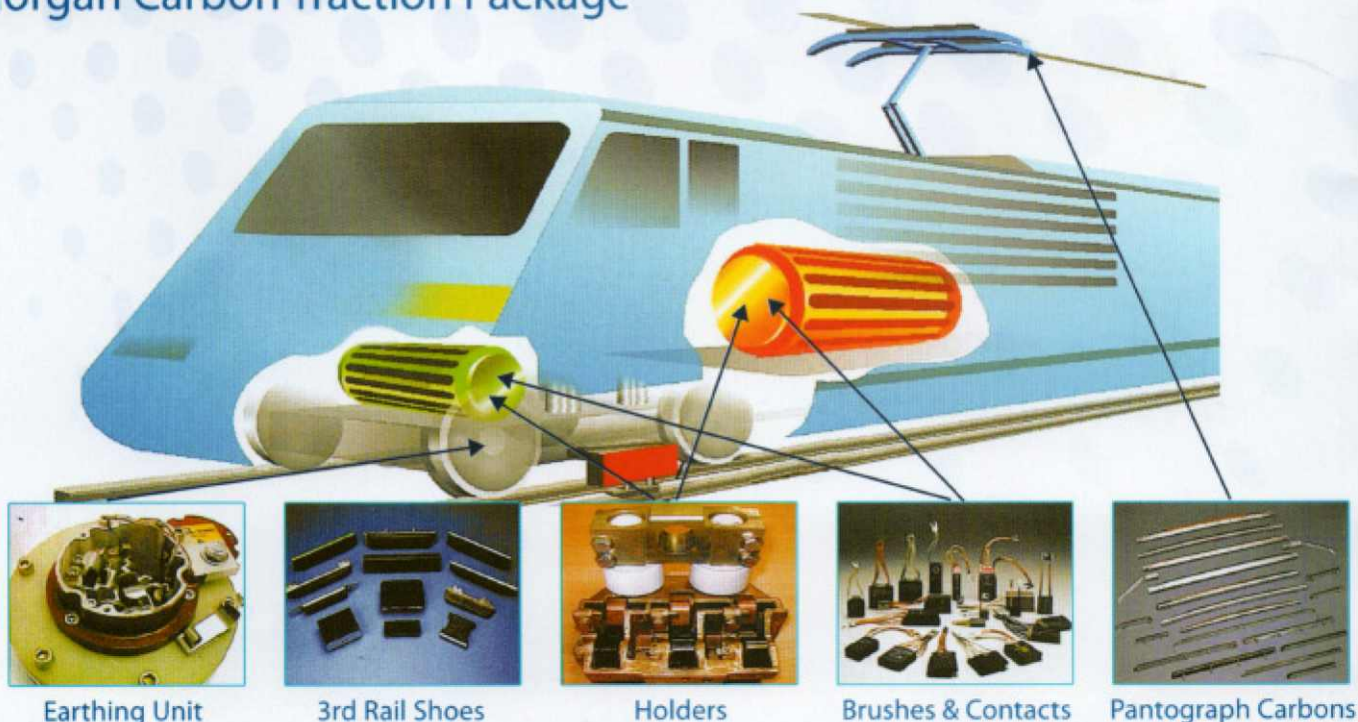
Morgan Carbon Traction Package

Earthing Unit

3rd Rail Shoes

Holders

Brushes & Contacts

Pantograph Carbons

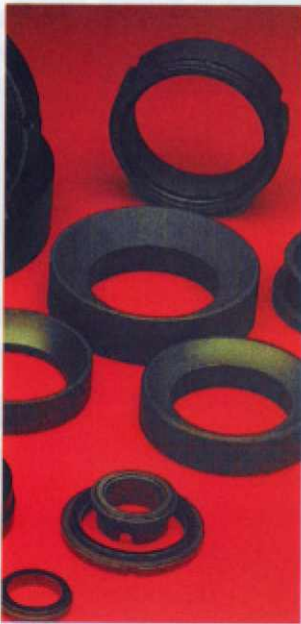
Sealing ring components

We supply sealing rings for all applications.

Carbon sealing rings are used as the wear face of most mechanical seals for the sealing of fluids in all industries.
