**MorganAM&T™**

*Traction Brush & Brush Gear*

**Morgan AM&T is a leading global supplier to the Railway Industry, providing products, services and solutions for electric motors and current collector systems.**

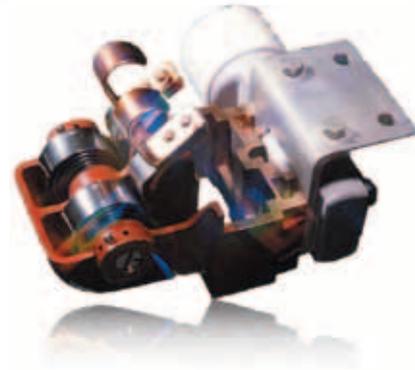
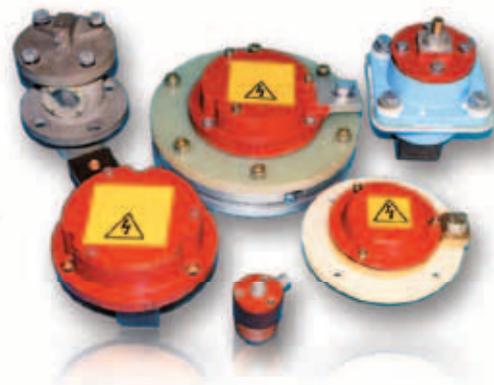
### Morgan New Improved Re-design

Our design team will take your current product and re-engineer it to optimise performance and improve reliability

- Design review
- Individual brush pockets to improve commutation and contact.
- Adopt semi-captive C/F.
- Springs can be replaced in situ.
- Include spring hold off facility.
- Weight reduction.
